The Effect On State Highways Of The San Fernando Earthquake

State of California
Business and Transportation Agency
Department of Public Works
Division of Highways

THE EFFECT ON STATE HIGHWAYS
OF
THE SAN FERNANDO EARTHQUAKE
FEBRUARY 9, 1971

SEPTEMBER 1971
SUBMITTED PURSUANT TO SB 682

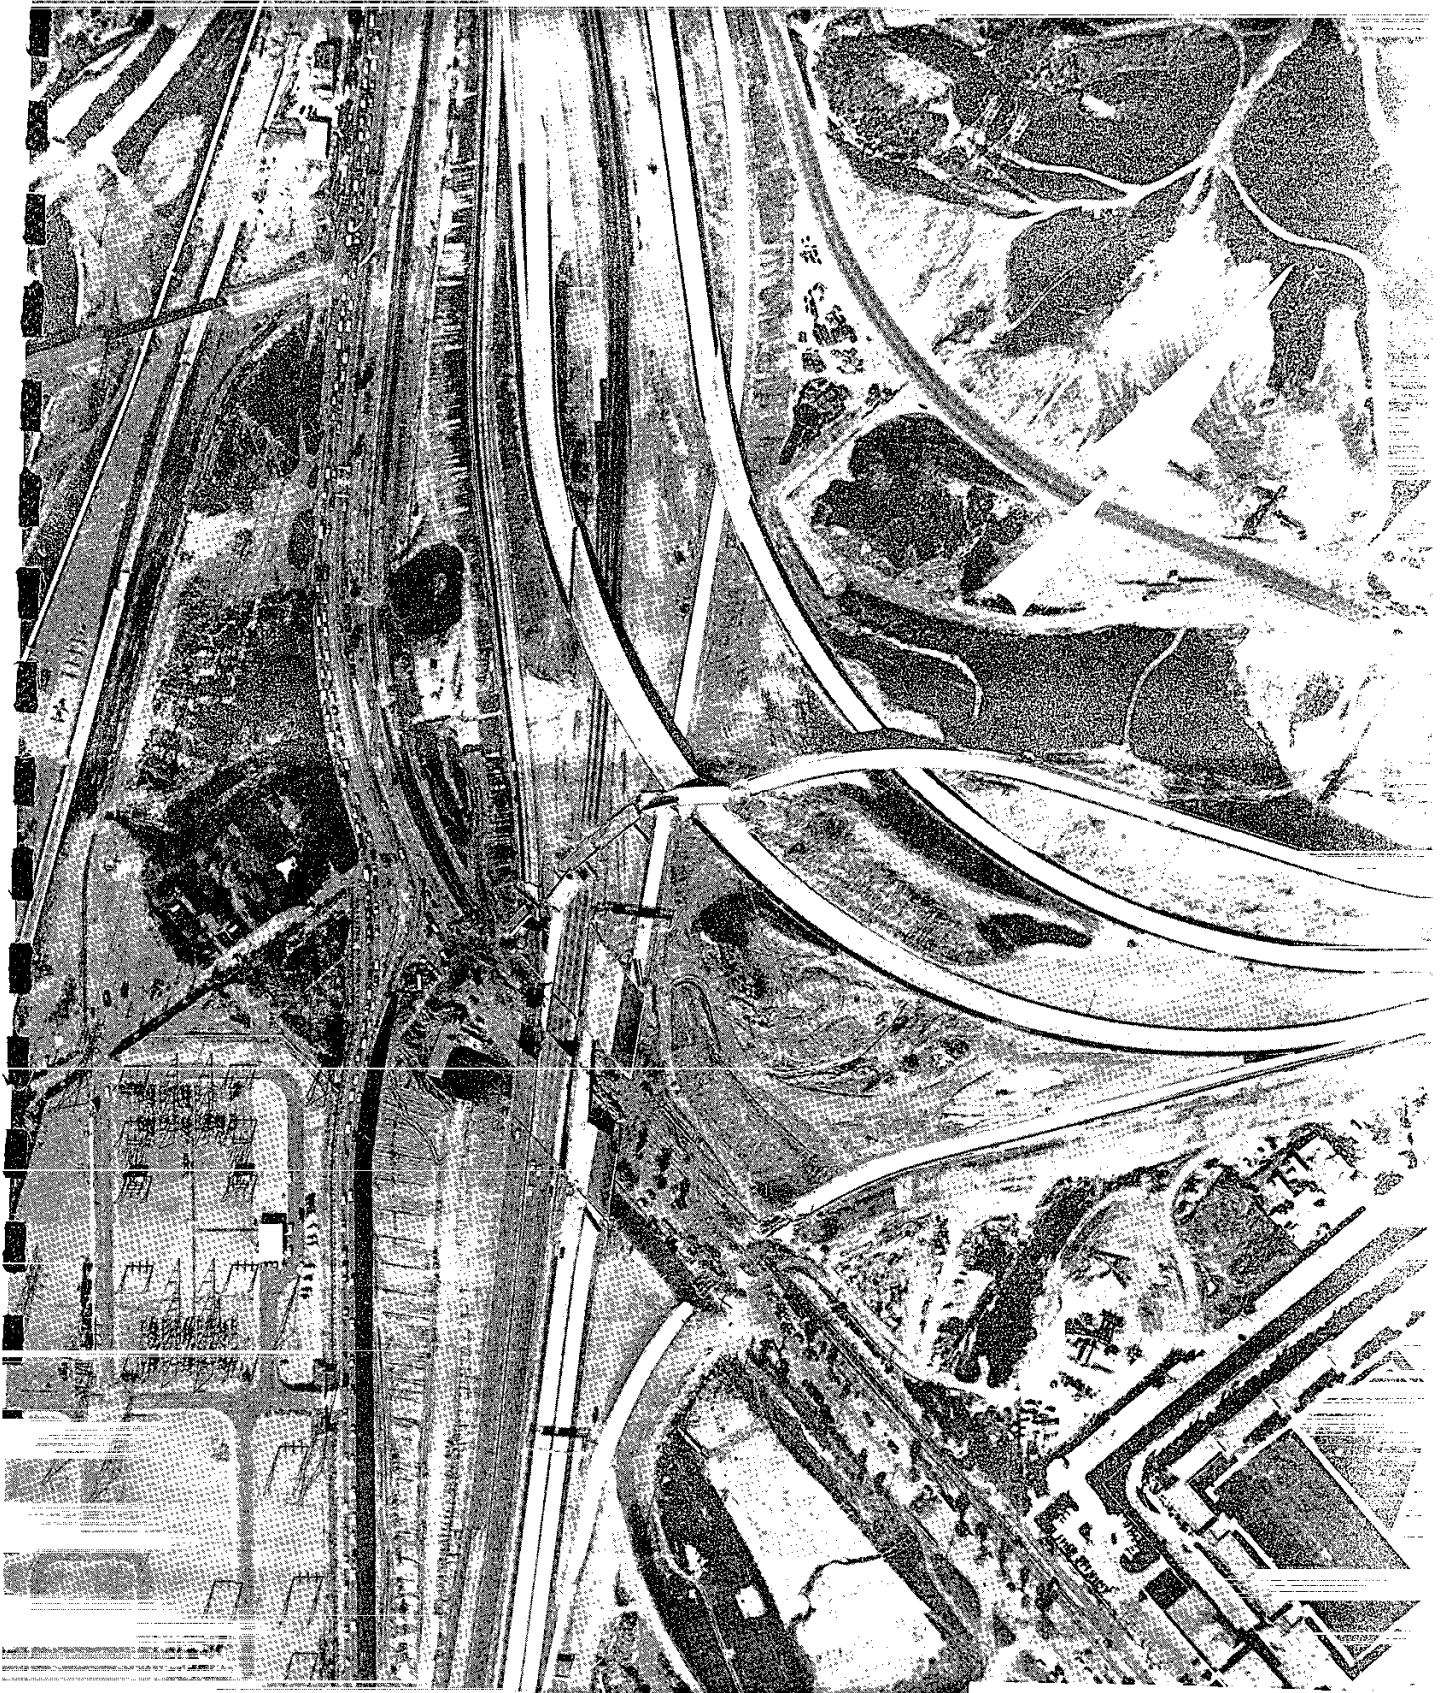
AERIAL VIEW OF
Route 5/210 Interchange
February 11, 1971
(two days after earthquake)

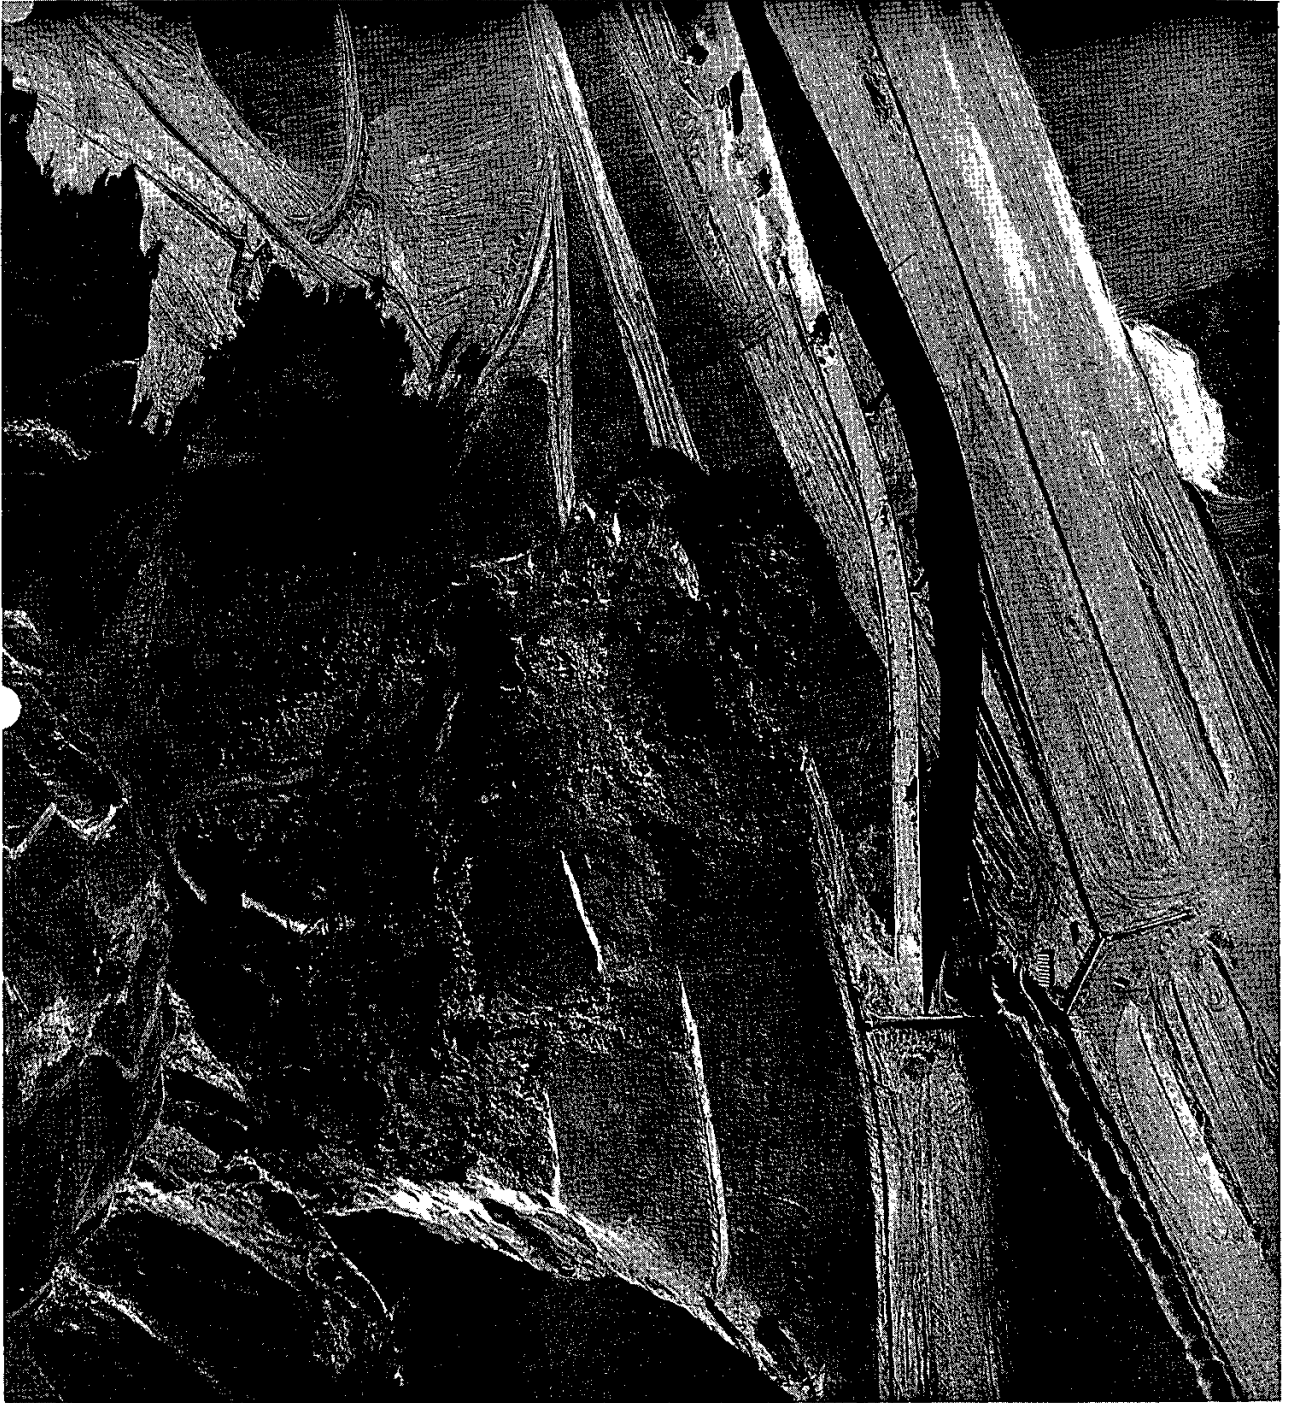
FIGURE 3. LANDSLIDE IN WELDON CANYON

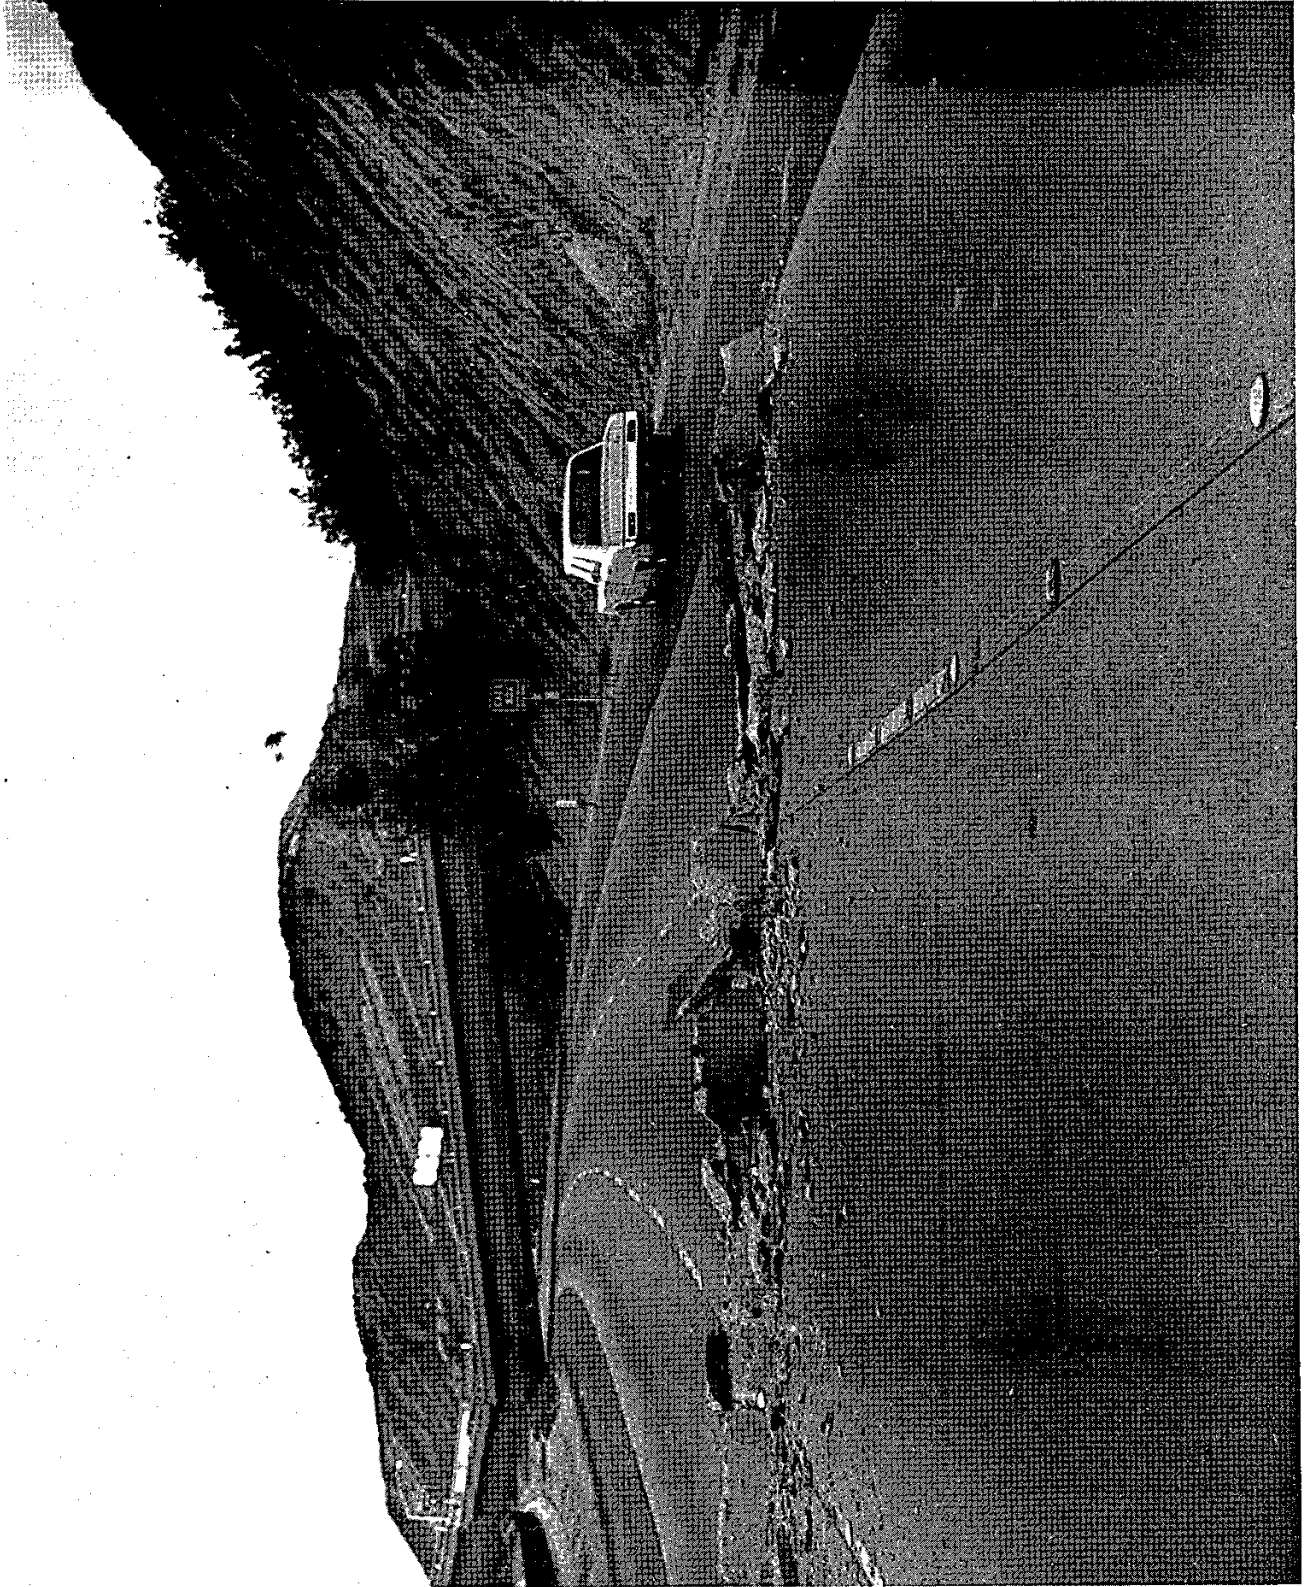
PHOTO 1

ON NB ROUTE 405 AT ROUTE 5

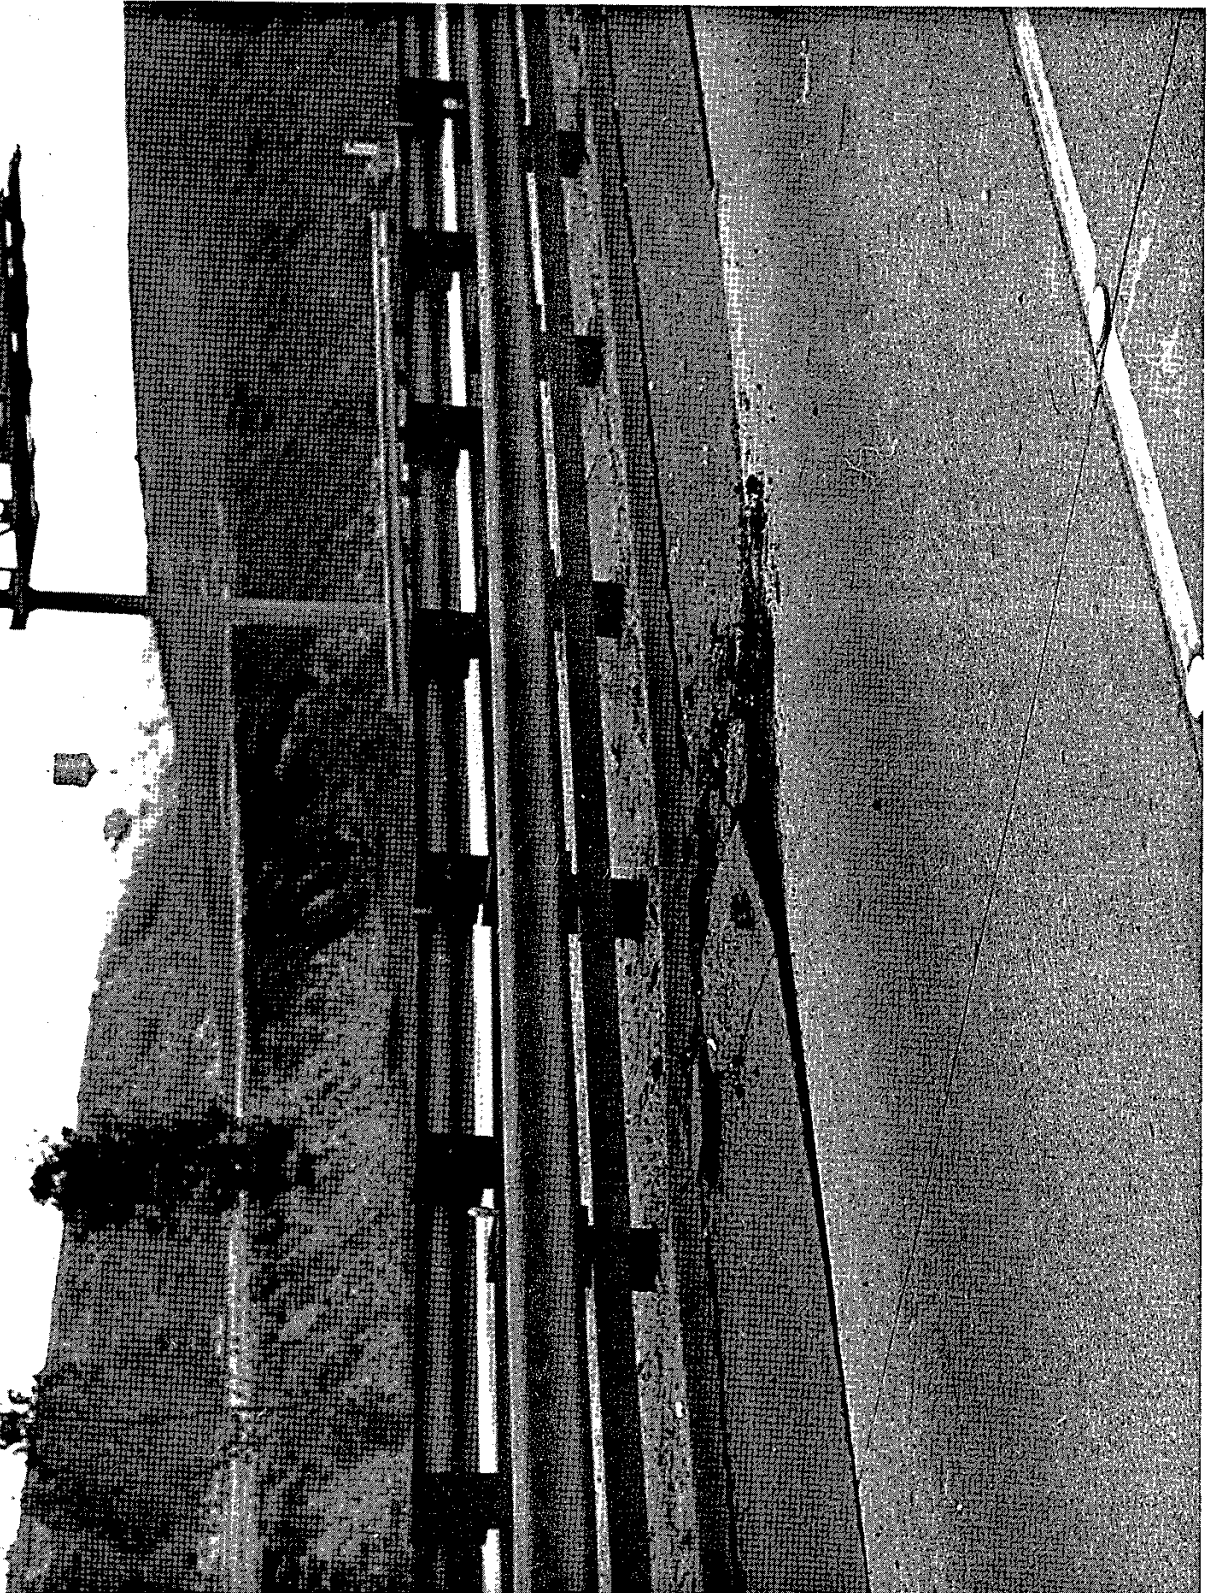
PHOTO 2

ON ROUTE 405 NEAR ROUTE 5

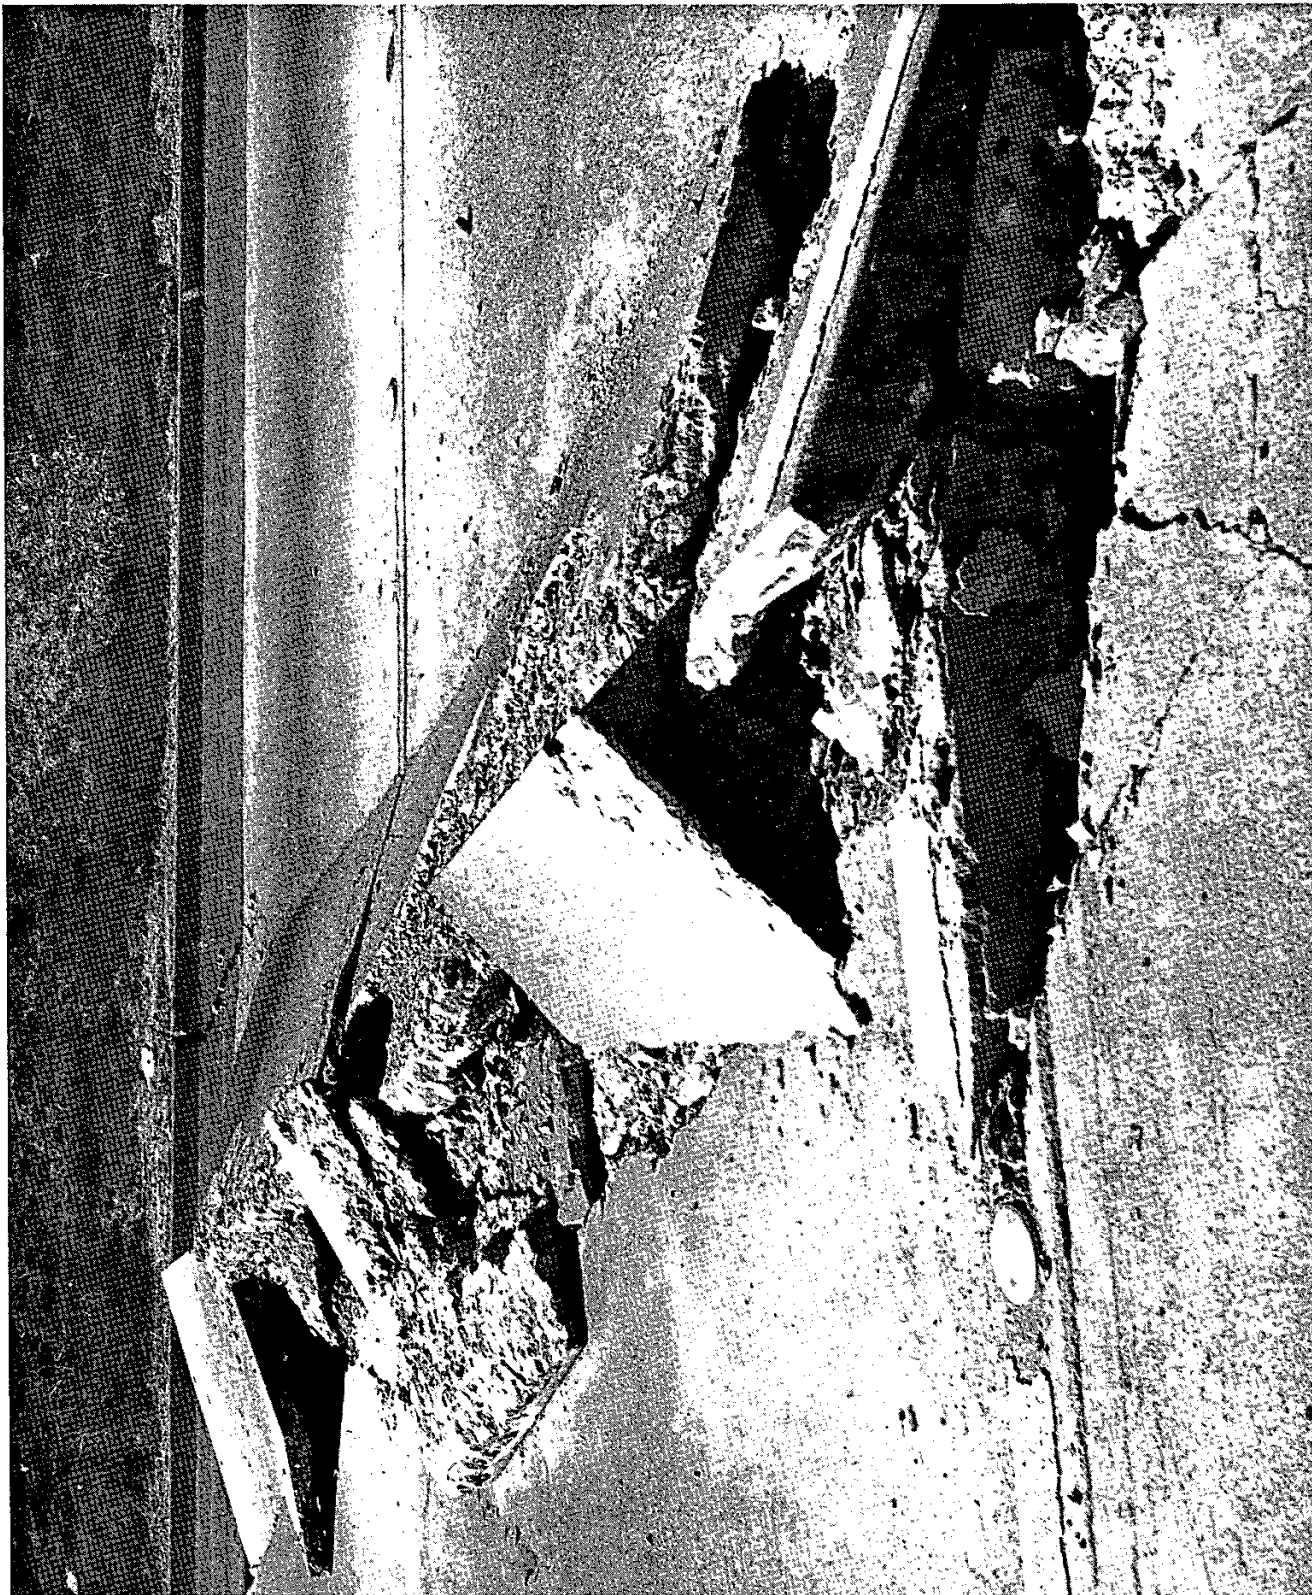
PHOTO 3

ON ROUTE 5 NEAR ROUTE 405

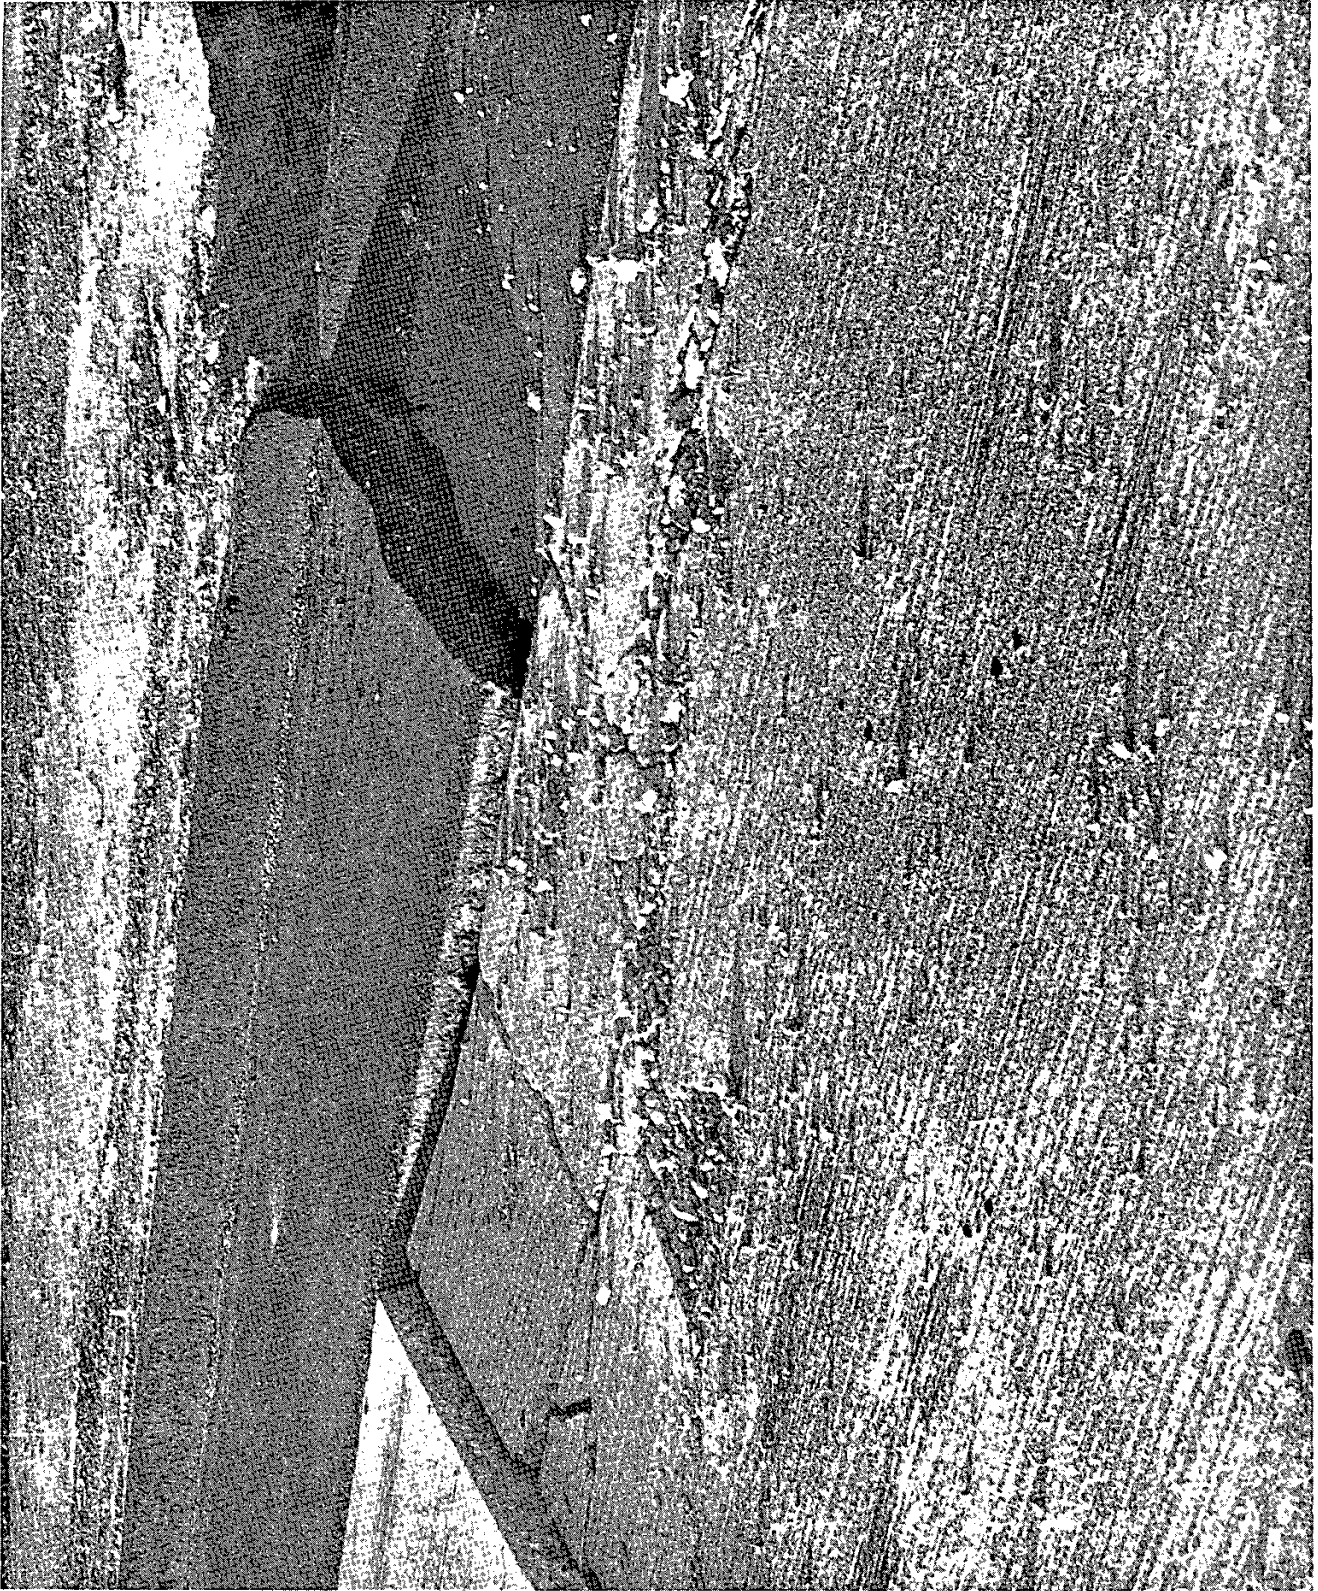
PHOTO 4

ON ROUTE 5 NEAR ROUTE 405

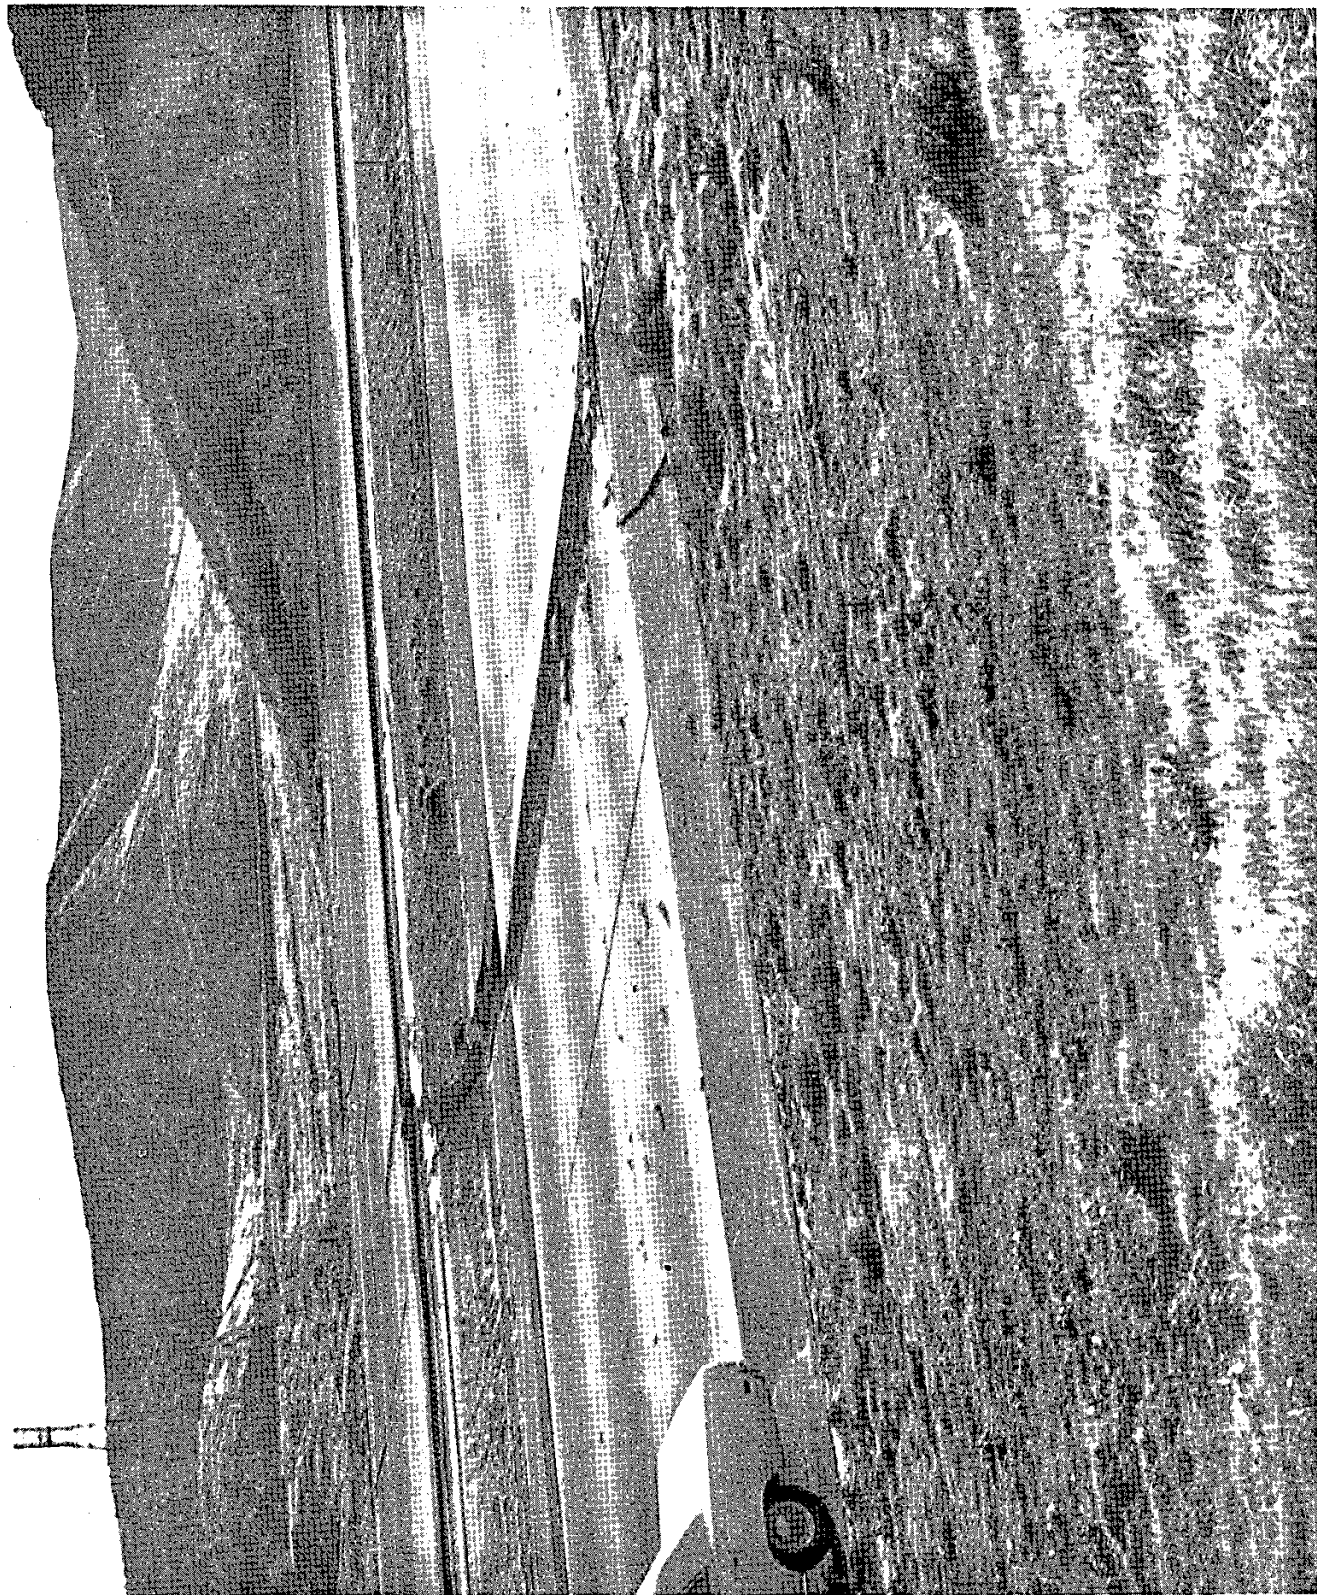
PHOTO 5

ON ROUTE 5 NEAR ROUTE 405

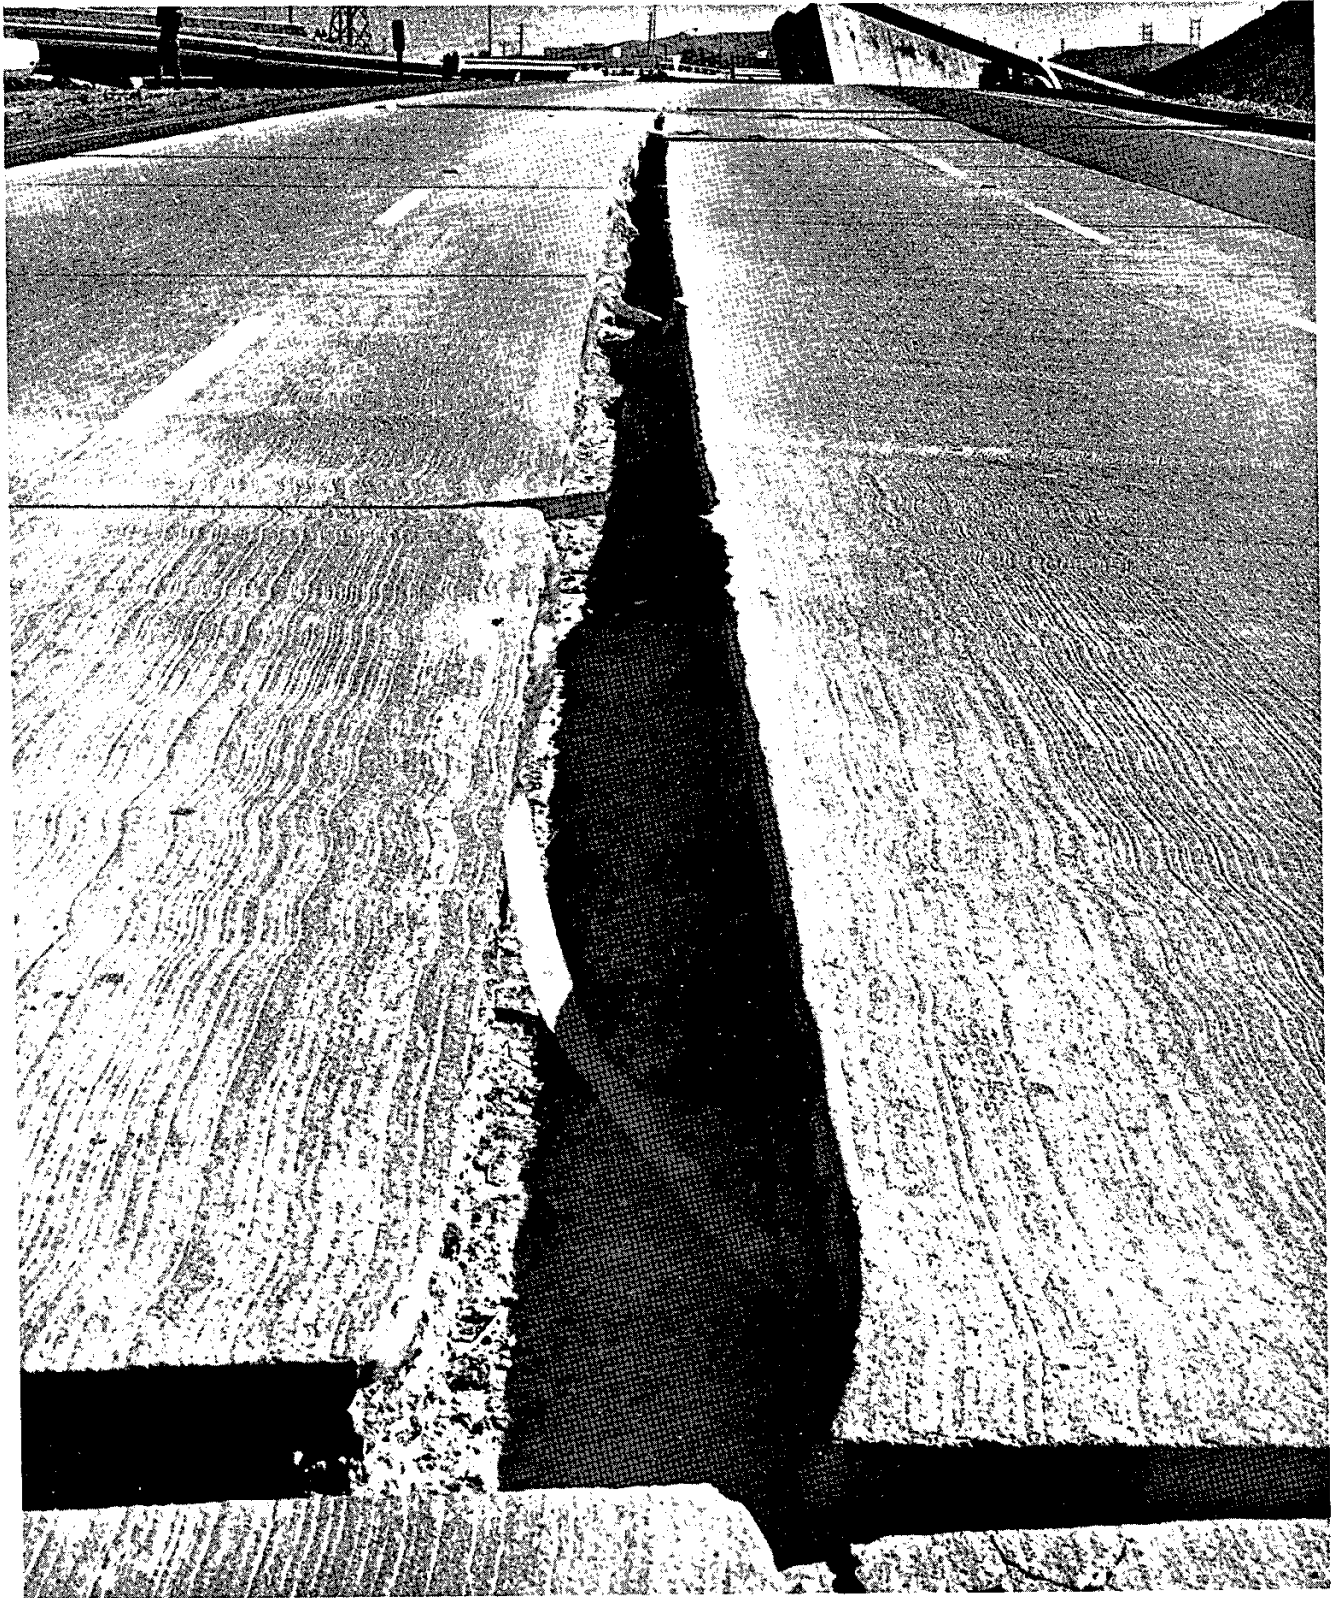
PHOTO 6

ON ROUTE 5 AT ROUTE 210
